AFAL-TR-79-1002

LASER PUMP LAMPS

ILC Technology, Inc.
399 Java Drive
Sunnyvale, CA 94086

Final Report February 1976 - September 1978

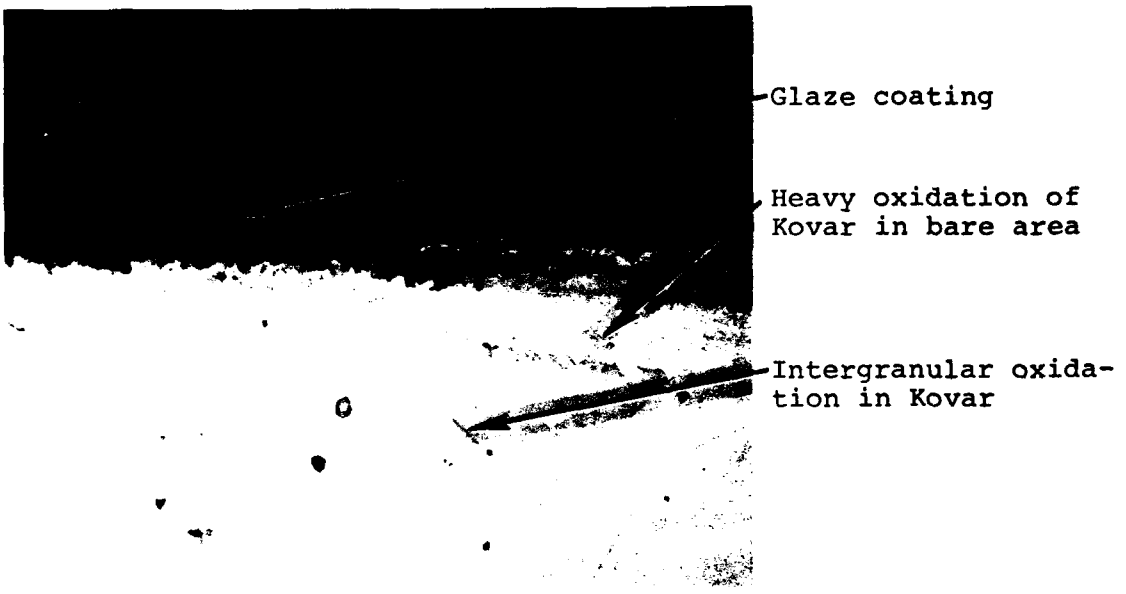
Figure 7. Photomicrographs of Kovar Oxidation in Glaze-Coated Weldment Region

The predominant failure mode was weldment leaks in the endcaps. Failure analysis on several failed lamps indicated that excessive oxidation of the Kovar had occurred during the glazing operation. In areas where glass coverage was inadequate the degree of oxidation was severe (Figure 7). In these cases, additional oxidation apparently occurred during lamp operation until intergranular oxide stringers reached the inside of the lamp. Alkali metal attack of the metal oxide then caused relatively rapid failure.

It is believed that unnecessarily high glaze firing temperatures and long firing schedules were in large part responsible for the process-induced oxidation. Also, the need for more complete glaze coverage was obvious.

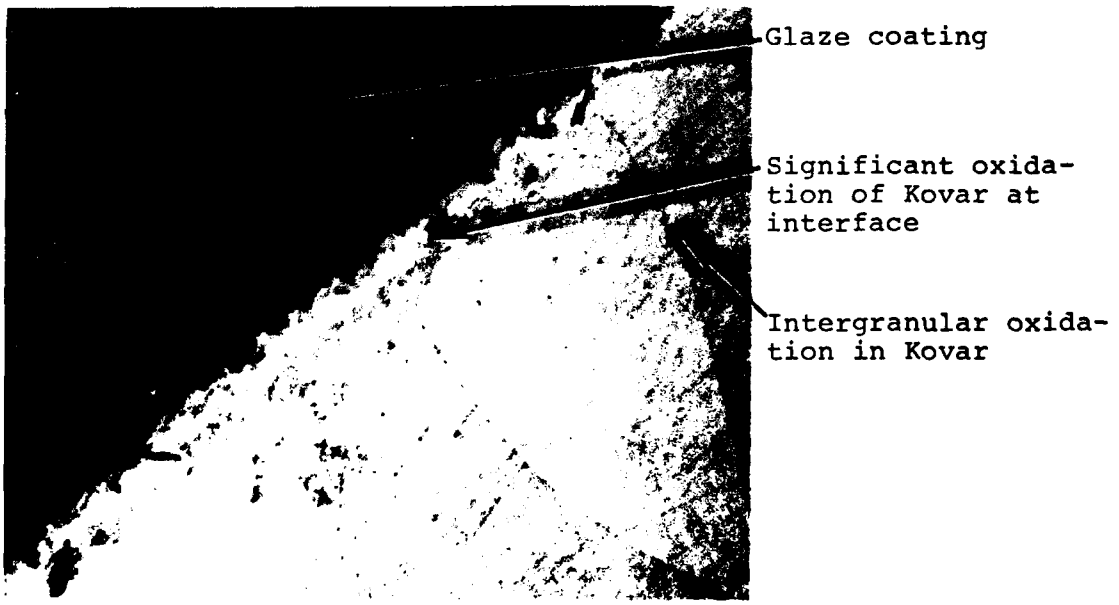
(a) Glazed and bare areas, approximately 200X

(b) Glazed area showing effect of process-induced oxidation, approximately 400X

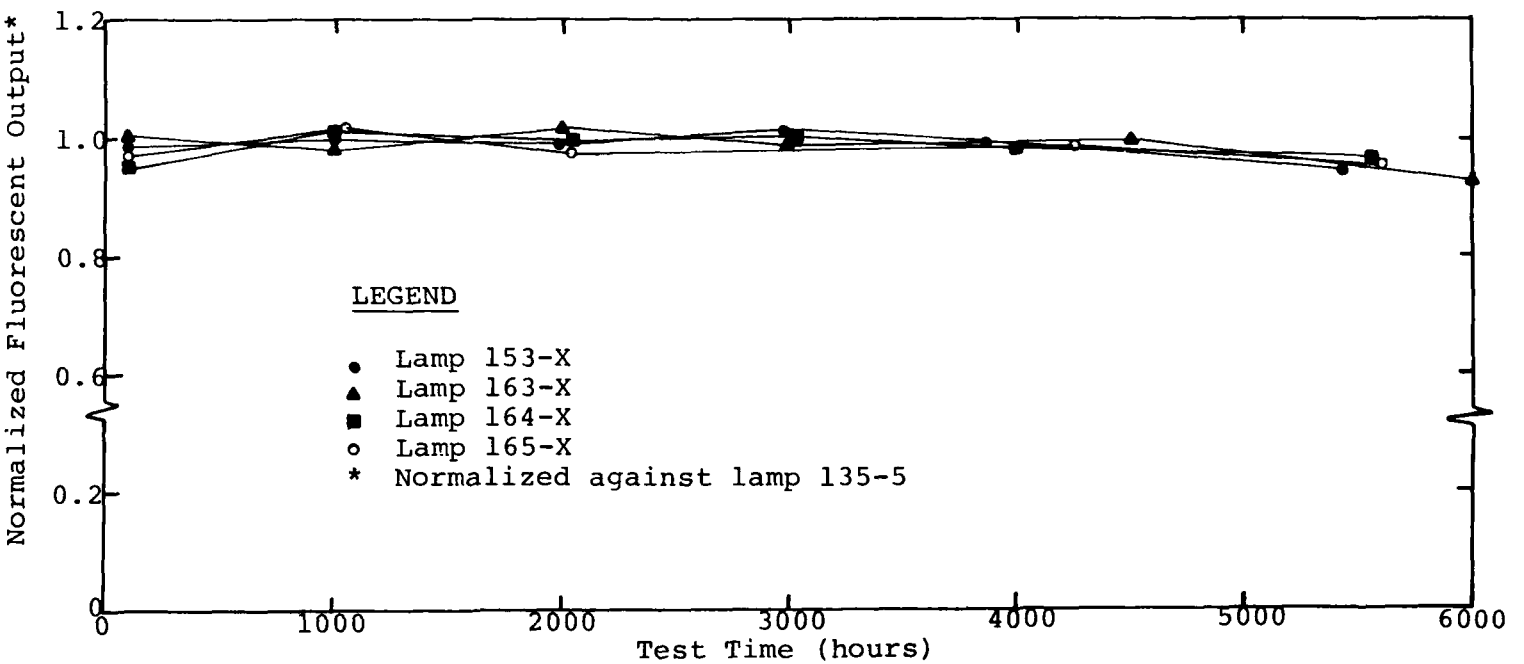
Figure 18. Output vs. Lifetime for Experimental Lamps with Pointed Tungsten Cathodes

Of equal importance was the fact that little fall-off in lamp radiant output (i.e., induced fluorescence) had occurred over the 5500 hour test period (Figure 18). The envelopes had remained in good condition (Figure 19) except for haziness near the anodes in lamps that had been inadvertently operated in the xenon mode (see Section V-B). Moderate deposition had occurred adjacent to the electrode tips and

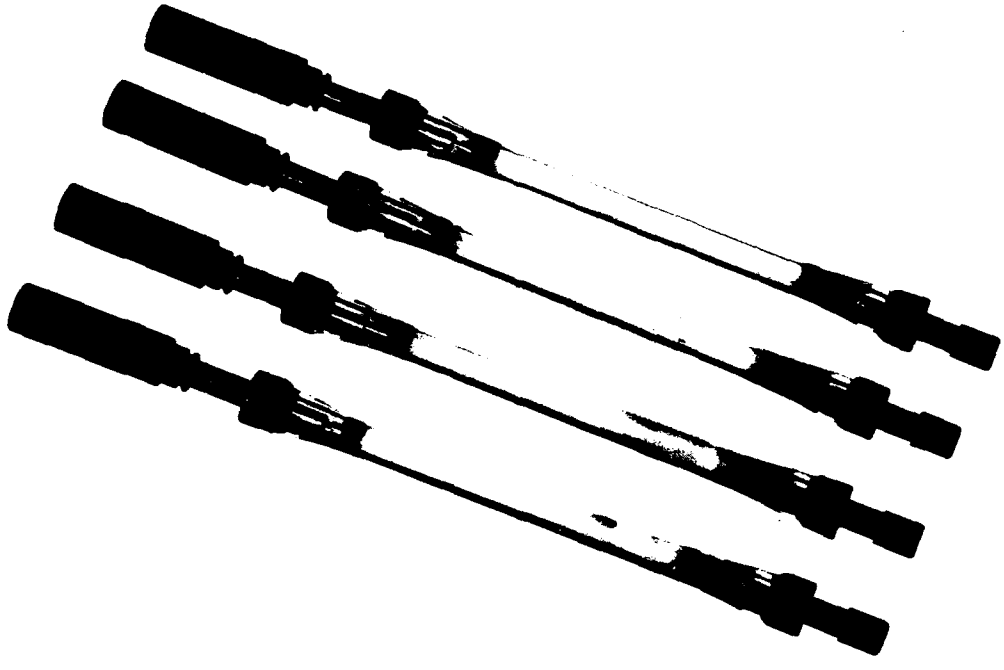
Figure 19. Sapphire Envelopes after 5500 Hour Life Test, Experimental Cathode Lamps

Lamp Number	Lifetime		Remarks
	Cycles	Hours	
153-X	140	5424	Some frosting on envelope caused by xenon mode operation; no BPCC's
163-X	131	6070	Heavy frosting near anode caused by xenon mode operation; at least four small BPCC's
164-X	128	5556	Envelope in good condition; no heavy frosting or BPCC's
165-X	124	5576	Envelope in good condition; one small BPCC

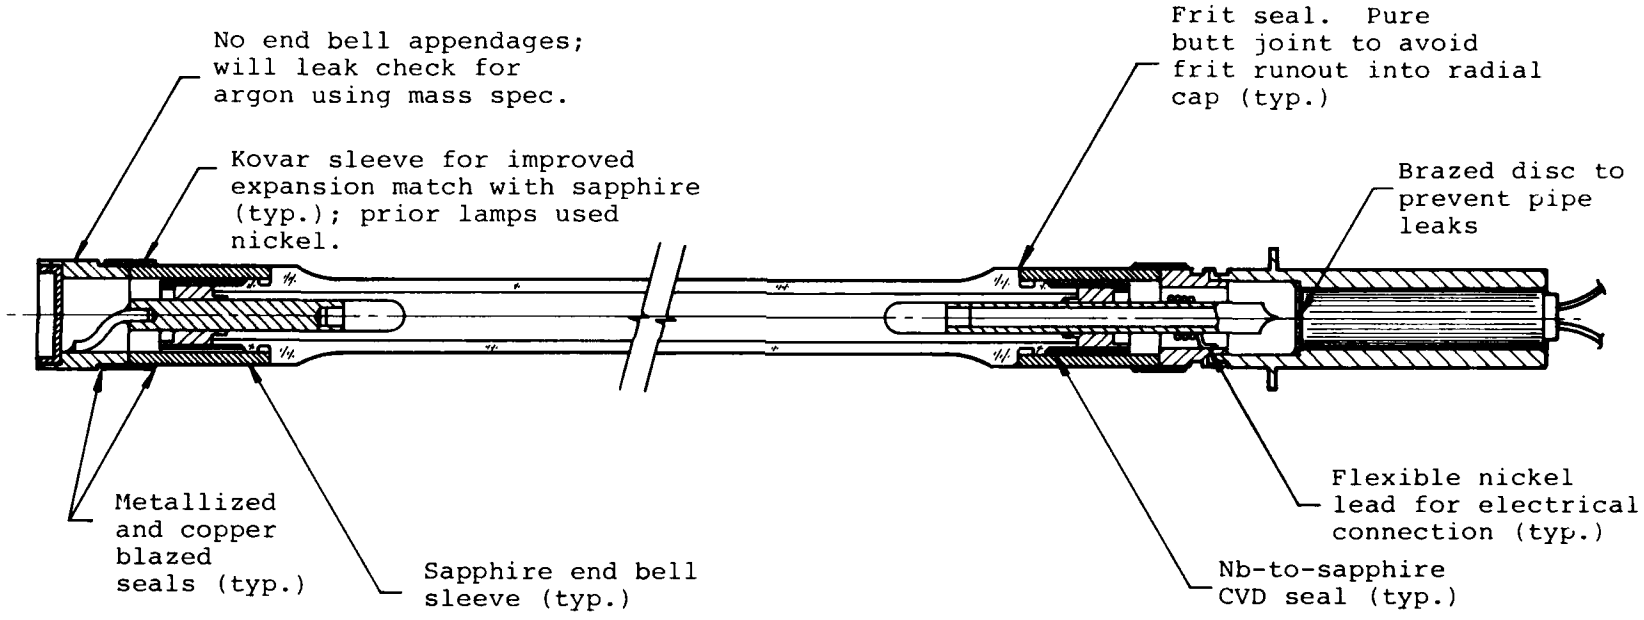
Figure 20. Protected End Seal (PES) Lamp Design

It was believed that frit seal cracking might be the consequence of a deficient joint design. Specifically, the localized capillary flow of molten sealing glass into the tight annular space between the primary sapphire envelope and the overlapping sapphire endbell sleeve (see reference 6, Figures 1, 2, and 3) was thought to promote regions of high mechanical stress in the joint. Accordingly, the joint design was modified with a relief groove machined into the sapphire envelope adjacent to the intended butt seal surface to eliminate capillary forces and cause the glass to remain in the intended area.

During fabrication, the first envelope assembly developed a CVD seal leak during the endcap-to-envelope welding operation. These weldments were successfully made on the second assembly but in the subsequent frit sealing operation the sapphire envelope and endbell sleeve cracked at one of the frit seals during cool down. No further work was done on PES lamp fabrication.
